**Your
Home Inspection Report
for:
16007 Penick Rd**

PROPERTY INSPECTION REPORT

Concerning: 16007 Penick Rd, Waller, TX 77484
(Address or Other Identification of Inspected Property)

By: David Gabriel, Lic #20593 04/30/2015
(Name and License Number of Inspector) (Date)

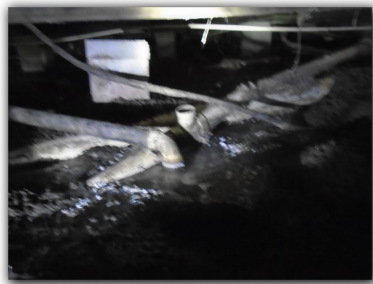
Observed large amounts of water pooling under home from leak and disconnected drain.

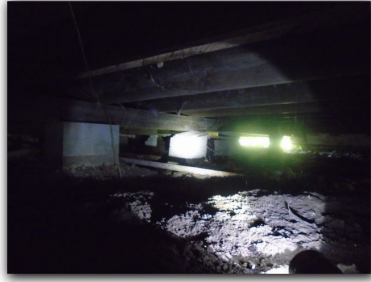
Piers under structure have shifted. Recommend having a foundation specialist inspect the structure.

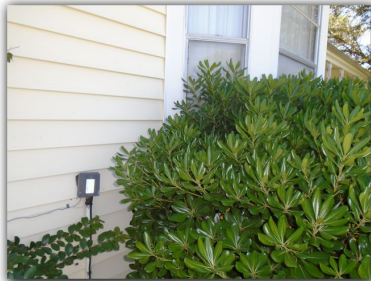
Structure has heavy foliage. Recommend trimming foliage away from structure to reduce the possibility of insect invasion.

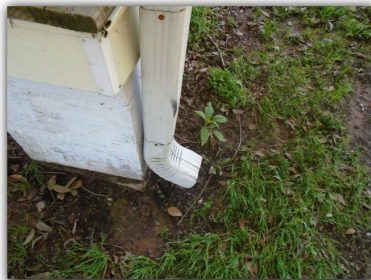
Missing splash plates for the gutter system in various locations.

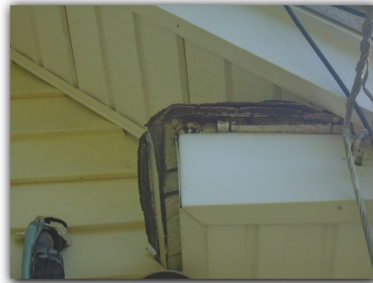
Observed decayed decking.

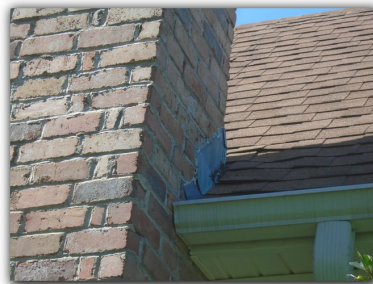
Flashing needs resealing

Observed bowed shingles near fireplace. Possibly from foundation movement.

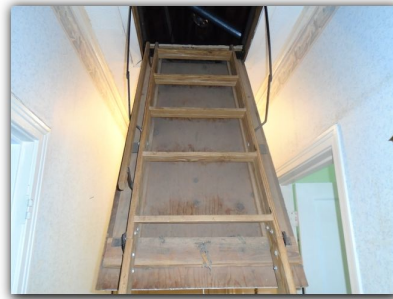
Observed no insulating cover or insulation installed on attic access. Recommend installing a insulation cover over attic ladder. This will help with energy efficiency for the home.

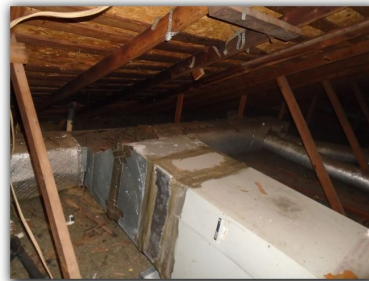
Observed missing/cut framing members. This has caused the roof to develop a noticeable sag. Recommend repair.

Framing in this house is not up to today's standards.

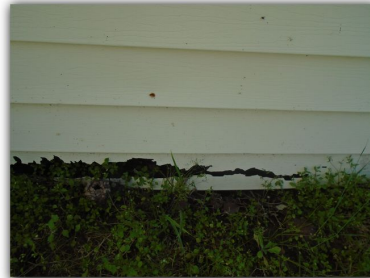
Observed some damaged siding or trim. Recommend replacing all damaged areas to help prevent possible water or insect penetration to the structure.

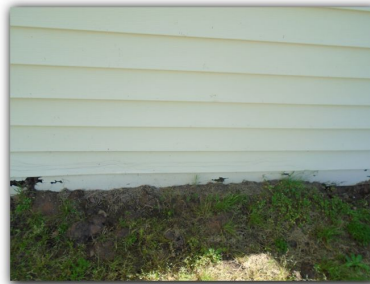
There is wood in direct contact with the soil around the structure. This condition may result in wood rot and possible wood destroying insect activity.

Sealant is separated, deteriorated or missing in some areas. Seal all cracks and holes on exterior walls to prevent water damage to the structure. This includes areas where different siding materials meet, where walls come together, around windows and doors, and where plumbing or wiring enters the exterior wall. **Photos are representative of the issue and may not include all.**

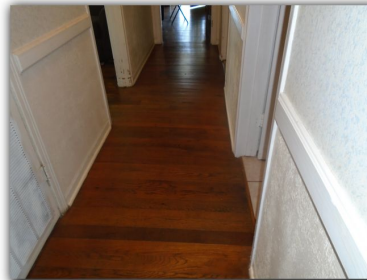
Flooring was uneven or was not level in various locations. This condition is more common in older homes. Water penetrations and foundation settlement account for most occurrences. In some cases it may be possible (and recommended) to remove floor coverings to inspect the sub-flooring. The homeowner must give special permission. The Texas Real Estate Commission (T.R.E.C.) does not permit the inspector to remove or pull away floor coverings.

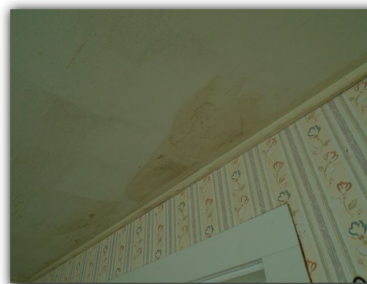
Evidence of moisture, stain or a foreign substance was detected in the ceiling. Moisture sensors are sometimes used to try to determine if the stain is active. There was no moisture detected at the time of the inspection. These areas should be cleaned, reconditioned and monitored for further activity as there are sometimes more than one obvious cause for water penetration.

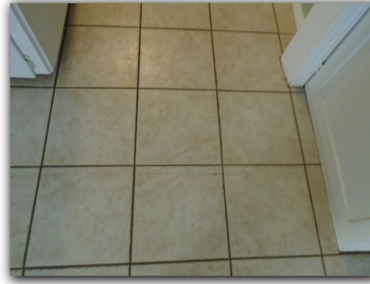
Observed cracks or chips in tile floor.

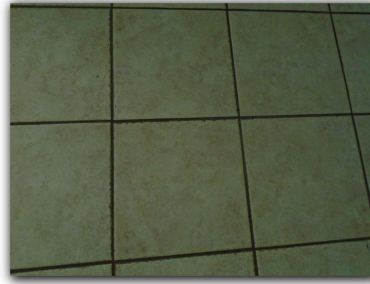
Ceramic tiles have a "hollow" sound when tapped with a hard object, indicating the tiles may not be well adhered to the floor, or the floor may not have been properly leveled during installation. This condition may lead to performance problems in the future. Future repairs or re-installation of the tiles may or may not be required. *Photos are representative of the issue and may not include all instances of the issue.*

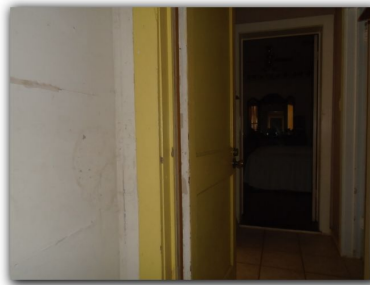
The door between the garage and the living portions of the home was not a self-closing door. The method for a self closing door may be spring-loaded hinges, automatic closers, or other approved devices. The reasoning for this requirement is to help insure proper fire breaking is maintained as well as helping to prevent carbon monoxide etc from entering living spaces when auto etc. are started, running etc. in the garage.

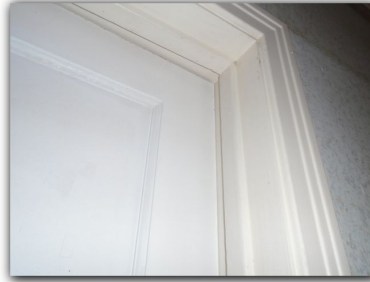
Doors rub, stick or hit frames in various locations.

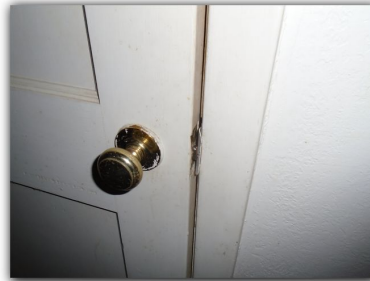
Doors do not latch or lock properly in various locations. Recommend adjusting or replacing striker plate.

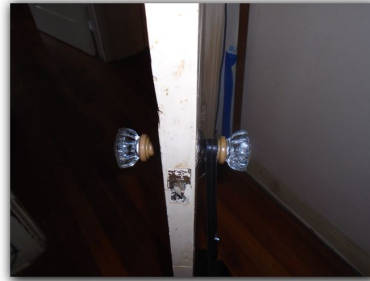
Observed interior door(s) with damaged or not functioning hardware.

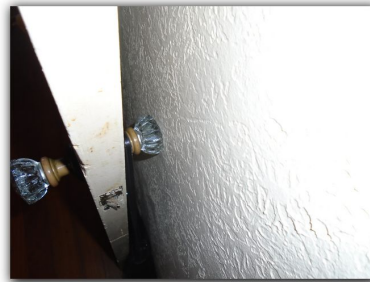
Door stops are missing,damaged or need repositioning in various locations. The installation of door stops on all doors will help avoid damage to walls and door hardware.

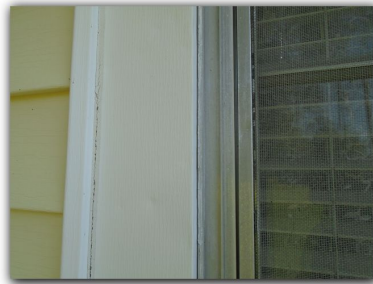
Windows need caulking/sealant to prevent possible moisture penetration.

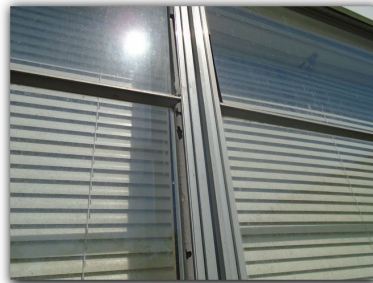
Window's broken seals were noted during the inspection. (The specific locations are not given because a window seal could be broken and not noticed for some time) this allows moisture inside between the panes of glass.

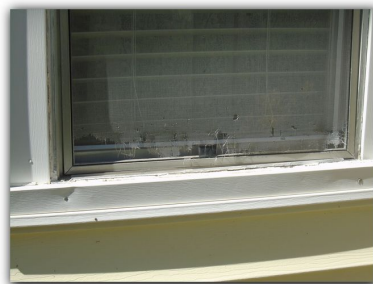
Window screens were observed that are missing or torn. Screens that are torn enough to allow insect infestation should be repaired. All windows that have channels for screens should have them installed.

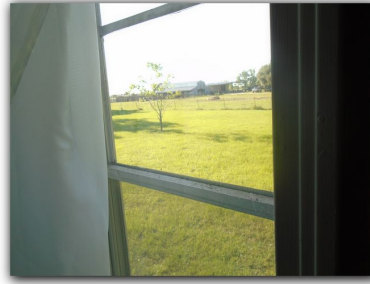
Observed windows are not readily openable for emergency escape.

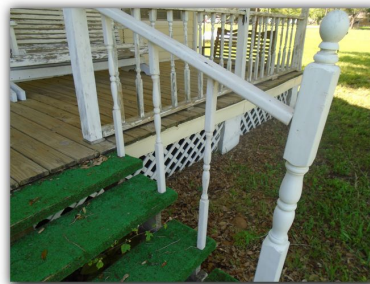
The spacing between these posts in your home may not meet today's standards. If the spacing of these posts is more than 4 inches we mention it in our report to our clients because it may be a safety concern with regard to small children.

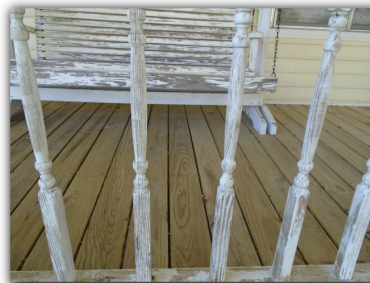
Spacing of posts on balusters and banisters that are higher than 30 inches above grade is changing in the industry. The spacing of these posts should not exceed "4" inches. Because it is a safety concern with regard to small children, T.R.E.C. guidelines require that it be pointed out in this section of the report.

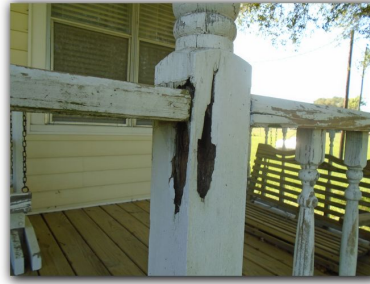
Wood decay (water damage) was detected on the surrounding deck, porch or balcony. Weathered lumber should be treated with a water proofing product. This oil based products can be purchased at most home improvement stores and are easy to apply. Water damaged elements should be replaced or repaired. This condition can also be conducive to insect infestation. Timbor is another product to protect exterior decking from various types of wood destroying organisms.

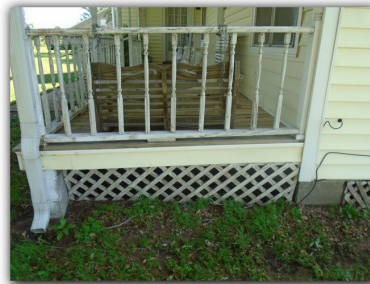
Observed significant settling at porch.

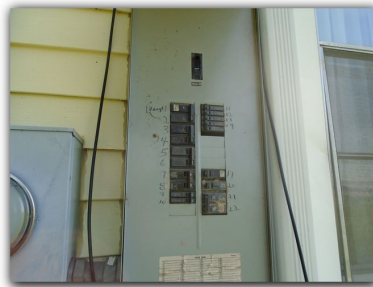
The circuit breakers are not identified and labeled. Proper labeling of circuit breakers can be crucial during an emergency situation.

Observed an absence of **Arc Fault Circuit Interrupters (AFCI)**

The 2008 National Electrical Code requires that essentially all branch circuits that supply outlets in new homes must be protected by AFCI devices. Homes built before this time are not required to meet this code.

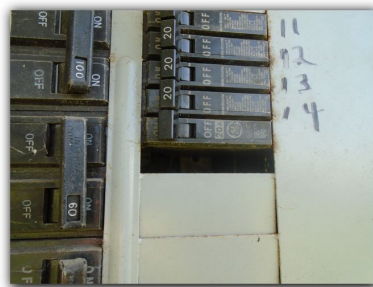
Knock out spaces for the breakers in the breaker box were exposed. Blanks are available that fill these voids at most home improvement stores. The gaps should be filled with snap-on covers.

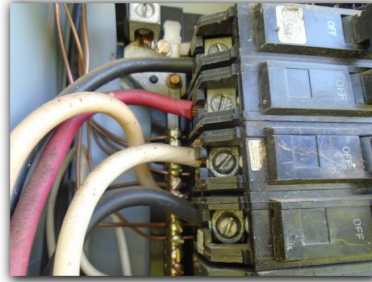
Observed white wire on a breaker/s that is not taped or marked black or red to indicate that it is a "HOT" wire, not a return neutral. A qualified electrician should repair this.

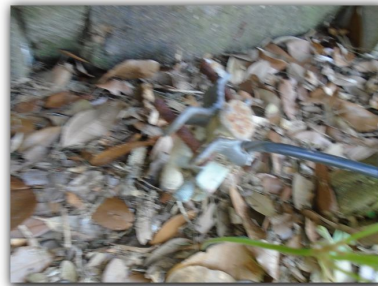
Observed the incorrect ground clamp in use. The correct ground clamp should be an acorn style clamp. Example pictured below:

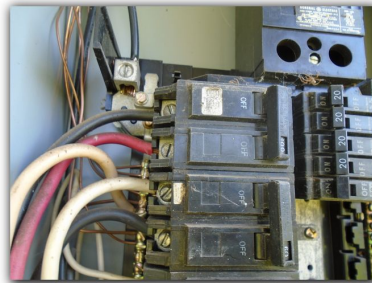
The wire gage does not appear to be rated for the attached breaker. Determining the capacity of the circuit is limited specifically in the T.R.E.C. guidelines. A licensed electrician can determine the correct hardware configuration. A licensed electrician should service the system.

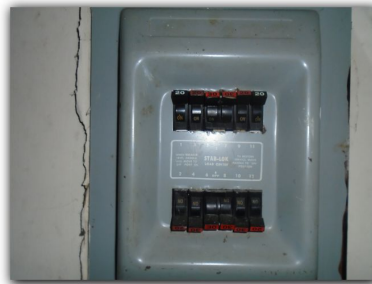
***** Safety Warning ***** Observed a Federal Pacific Electric "Stab-Lok" service panel in the house. This panel may be a latent fire hazard: this brand of circuit breakers may fail to trip in response to an overcurrent or a short circuit. Failure of a circuit breaker to trip can result in a fire, property damage, or personal injury. A circuit breaker that may not trip does not afford the protection that is intended and required. Simply replacing the circuit breakers may not a reliable repair. The buyer is advised to contact a licensed electrician for an expert opinion on this panel. Additional information about the fire and shock hazards associated with this equipment can be read on the internet at <http://www.inspect-ny.com/fpe/fpepanel.htm>.

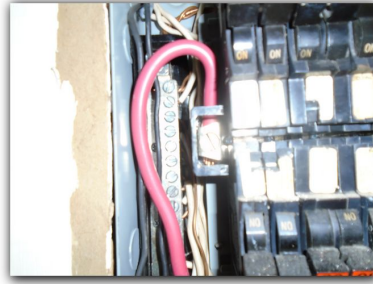
System does not appear to be properly bonded.

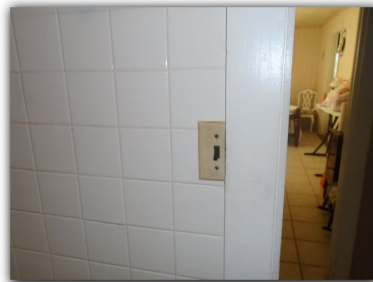
Observed switch is too close to water source.

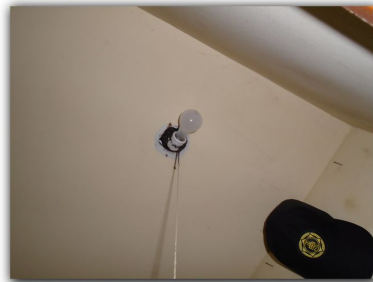
Observed various globes missing from light fixtures. This is a recognized safety hazard.

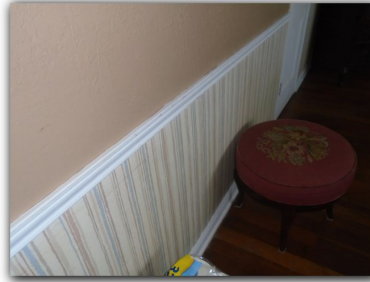
Due to the age of the home there are not a sufficient number of outlets in the home. Outlets should be installed so that no point along any wall is more than 6 feet from one. On the kitchen counters, no point should be more than 2 feet from an outlet.

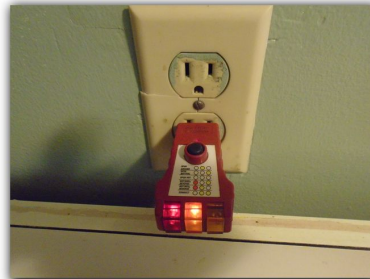
A polarity problem was detected on multiple plugs. Outlets are checked using a circuit tester. As fixing on outlet may cause other outlets down the line to have problems.

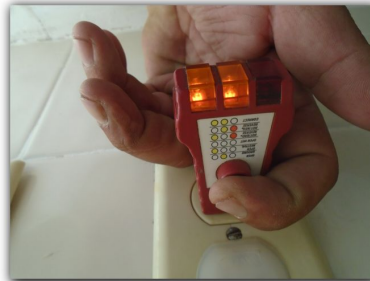
This structure is not properly protected by GFCI (ground fault circuit interrupt) breakers. This is a required statement by the T.R.E.C. (6/13/94) GFCI breakers are required at all outlets within 6' of any water source inside the house (kitchen sinks, bathrooms, wet bars, or utility room sinks), all exterior outlets, and all outlets in the garage except for one which should be set aside for an appliance like a refrigerator or freezer.

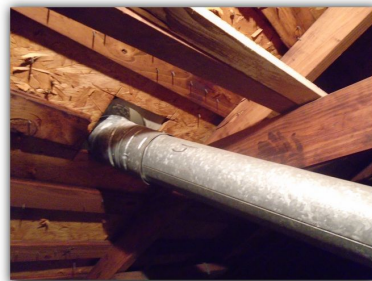
Observed missing strapping at vent.

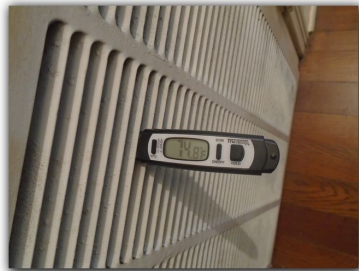
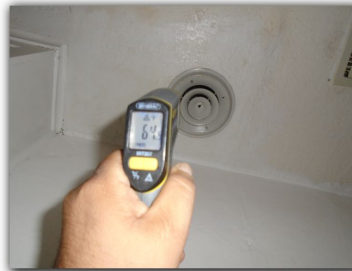
Delta-T 10 degrees'

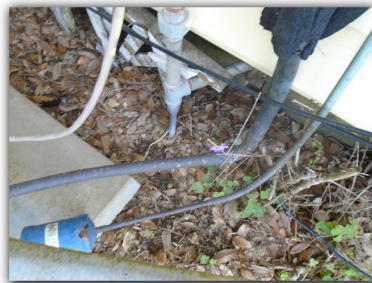
Refrigerant line was not fully insulated to the unit. This condition causes the line to sweat and slightly degrades the performance of the system. Applying foam tubes and taping may remedy this.

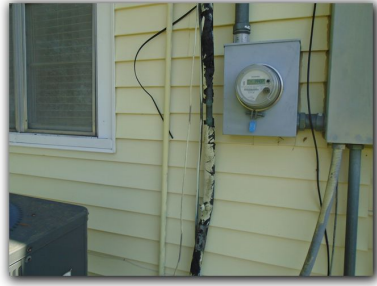
HVAC lines should be in a protective housing when running up the exterior of a wall.

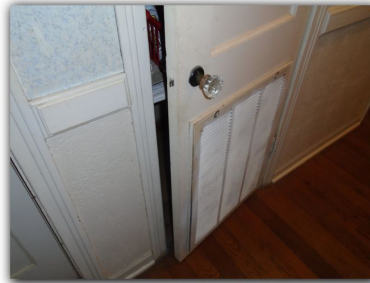
Observed return chase has been turned into closet. This does not allow proper filtration of air.

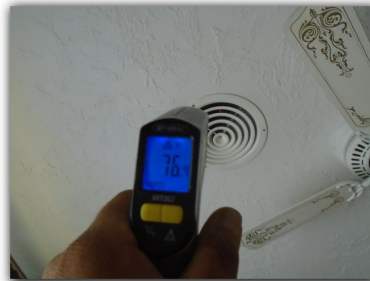
Observed areas of the home in which airflow is little to none. Recommend service to the system.

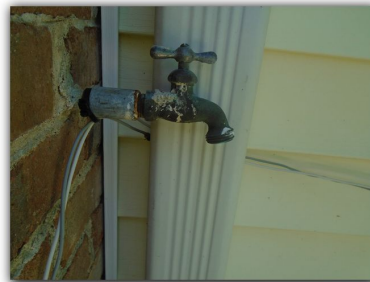
Observed dead valve.

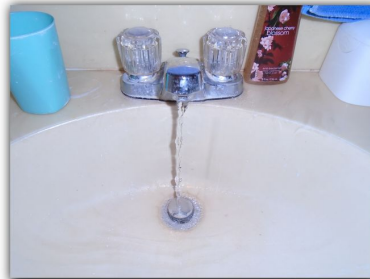
Low water pressure was detected at the faucet(s). Water pressure is determined by running two faucets at the same time. There is no guideline for flow rates. If the water pressure appears to be very low, it is mentioned in this report. As there are several causes for low water pressure, a licensed plumber should service the utility.

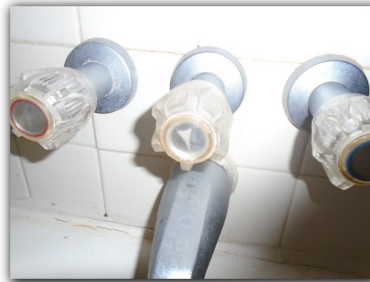
Shower diverter valve does not operate properly. This valve should completely restrict the flow of water from the bathtub faucet and direct the pressure to the showerhead. Weak or defective diverting valves should be repaired or replaced when they no longer function properly.

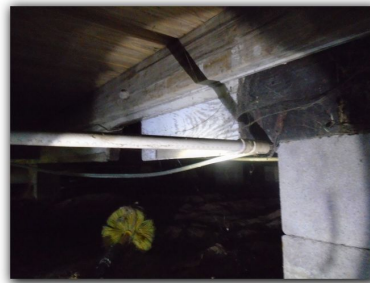
Observed exterior water piping material that should be insulated.

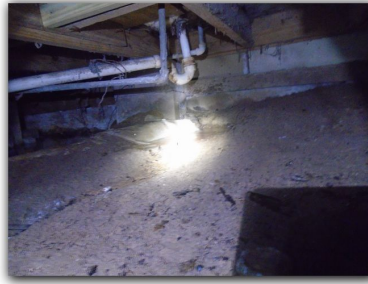
Observed leak under home. Recommend repair.

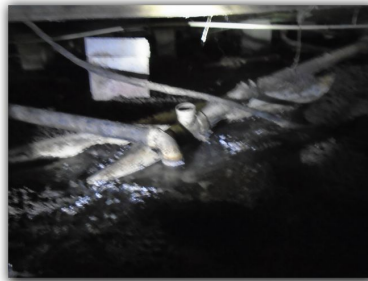
Observed drain disconnected under home. Recommend repair to prevent non potable water spilling under home.

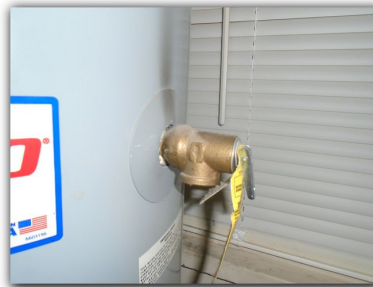
Temperature & Pressure relief valve (TPR) should drain into a line that is plumbed horizontally or down, but cannot go back up (this keeps debris from going back to the valve). This line can be 3/4 inch C.P.V.C. plastic (not reduced in size) and should terminate from 6 to 24 inches from the exterior ground with an elbow facing down. Remember to test the valve and replace it if it leaks or does not operate or every 3 years.

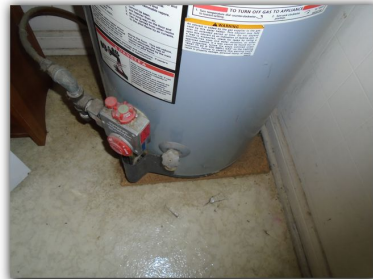
A safety pan underneath the water heater is recommended. A safety pan should be installed with a proper drain to the outside in case of a rupture or a leak in the tank.

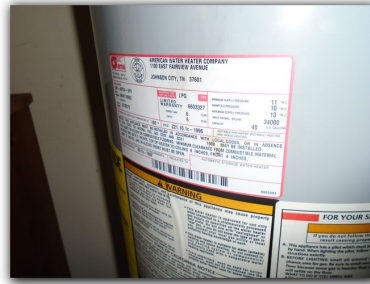
Age of unit appears to be beyond the average working life of water heaters.

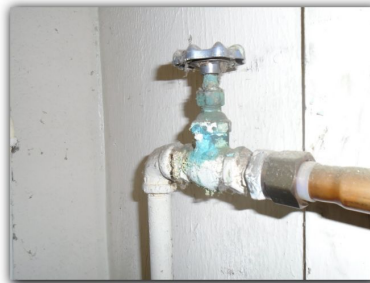
Corrosion was noted on plumbing connections to Water Heater. Corrosion on the plumbing connections near the tank is common. This is caused by bi-metal corrosion. Heavy corrosion may indicate the sacrificial magnesium anode at the top of the water heater needs to be replaced. Fittings that corrode to the point of leaking should be replaced. No leaking was detected at the time of the inspection.

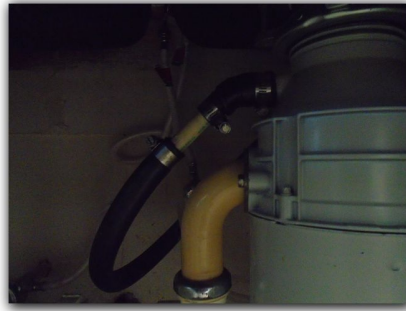
An anti-backflow condition is required in the dishwasher drain line. This can be accomplished by installing an air gap as illustrated, or by attaching the existing drain line to the underside of the countertop.

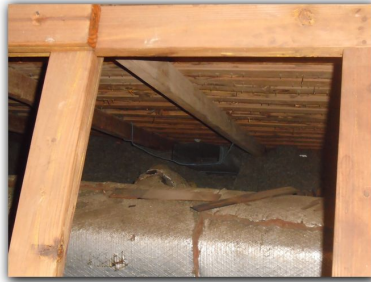
Hood vent is terminated into the attic. The vent should be terminated to the outside. The vent pulls all the grease and moisture up and should be deposited outside not in the attic area.

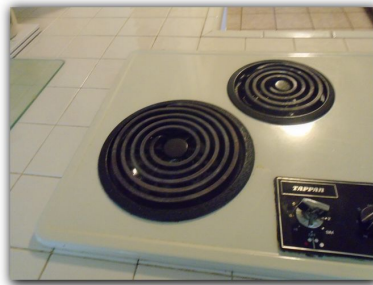
Burners/elements did not operate properly at the time of the inspection. Burners and heating elements are operated on low and high settings. If the burners or heating elements do not operate on one of these settings, it must be mentioned in this report.

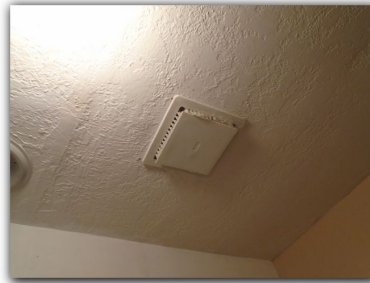
Observed units are extremely dirty. Recommend cleaning to prevent damage.

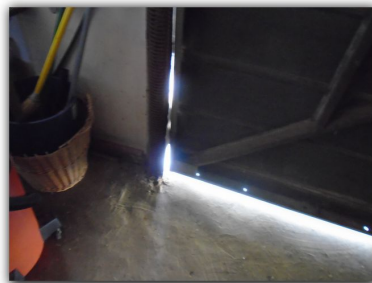
Electronic sensor of the automatic unit were not present at the time of the inspection.
